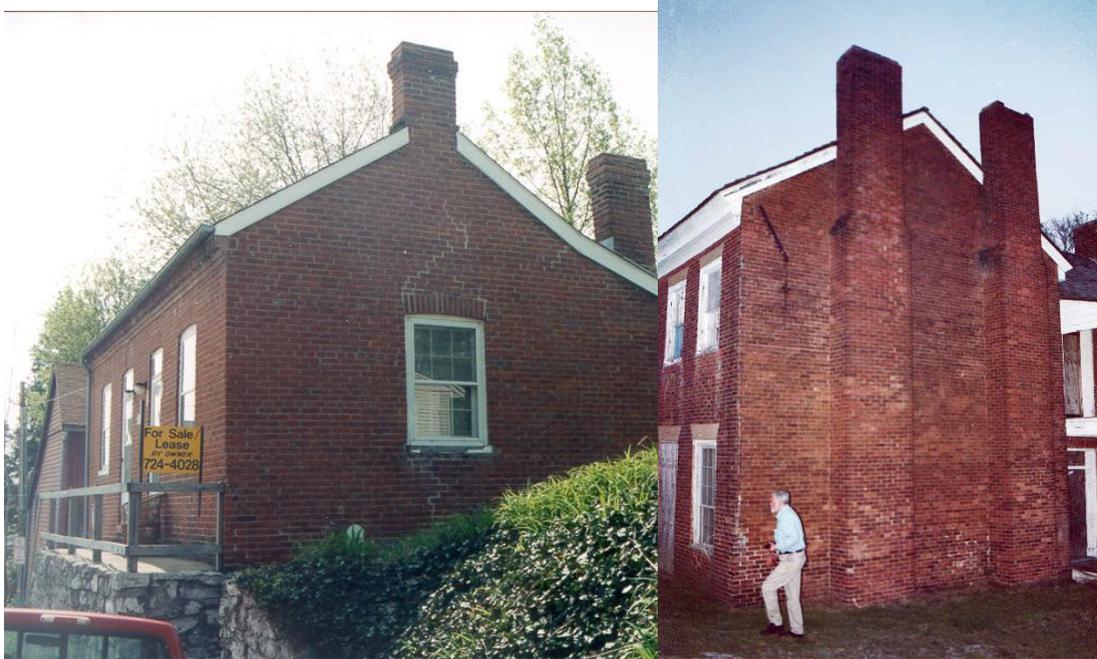
Examples of brick houses that pre-date the 1811-1812 sequence in St. Charles, Missouri (left), and Smithson, Kentucky (right). Cracks in the house at left were caused by later moderate earthquakes in the region; there is no original account of damage in either St. Charles or Smithson.
