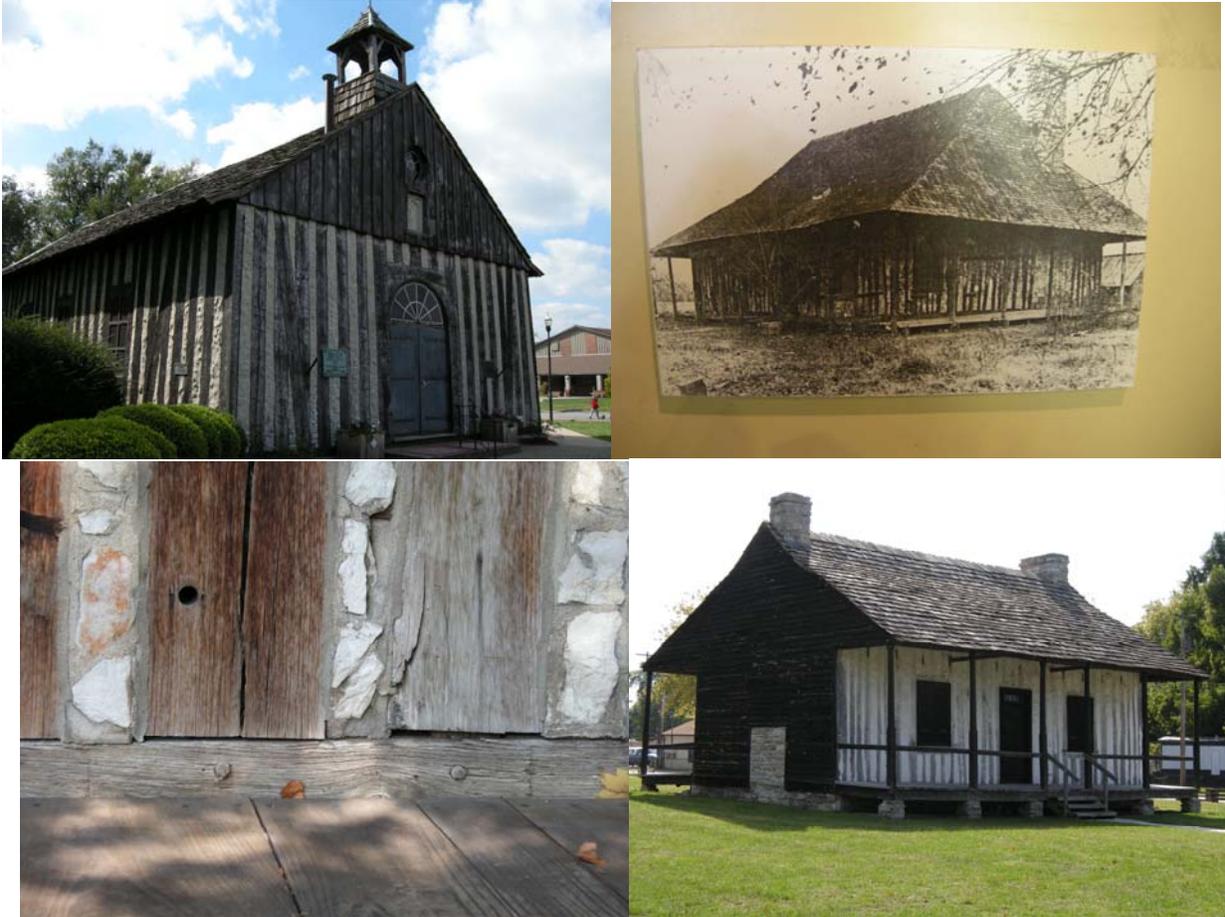
Post-on-sill construction in Cahokia, Illinois: Holy Family church (top left) and Old Court House (top right and bottom left), house (bottom right). There are no records indicating that either of the above structures were damaged by the earthquake, and the church, which is next door to the Jarrot Mansion, which did sustain some damage, shows no evidence of damage/repair. The reconstructed Old Court House (bottom left) reveals the original construction style: mortise-and-tenon joints between posts and the wood sill were secured with wood pegs.

General account from Cahokia: “A great many houses have been badly damaged, but no one was killed. The earth opened in many places, especially about three miles from the monastery. Only sand and water came from the opening. Fortunately our poor cabins of wood and sand can withstand a great deal of shaking without much danger. Their undress logs piled one on top of another can be separated only by considerable force. Some stone and brick houses have had to be abandoned.”
